Manhole Inspection Summary

Manhole # S37W1_004MH

Location Address: **3601 W. Patapsco Ave.**

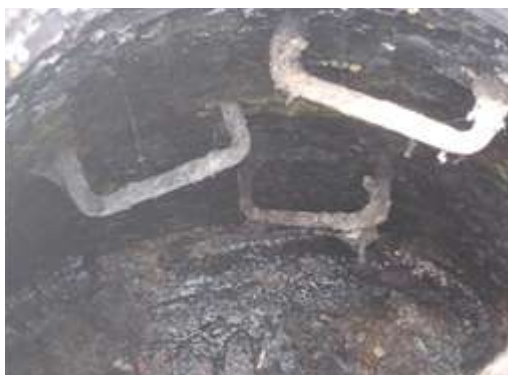
Steps

Count: **3** Missing: **0** ☒ **Corroded**

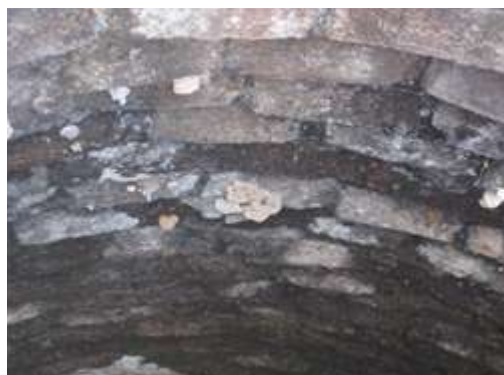
Defect 1

Infiltration: ☐ None ☐ Joint ☐ Cracks ☐ Mortar ☐ Roots ☒ **Wall**

Infiltration

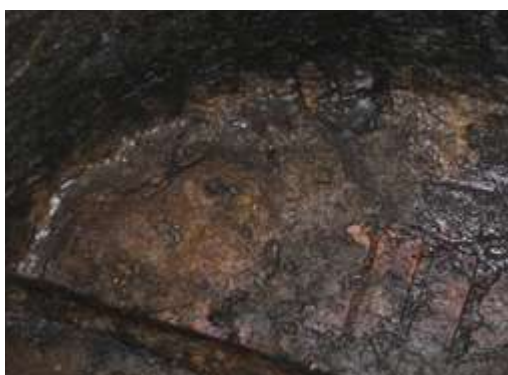
Defect 2

Condition: ☐ Sound ☐ Cracked ☐ Root Intrusion ☐ Deteriorated ☒ **Leaks** ☐ Debris

Leakage on the bench.

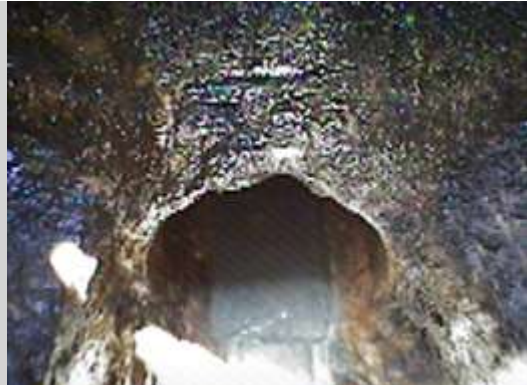
12 O'Clock Outflow

8 in. Circular Gravity Sewer
Pipe Out @ 12 O'Clock

Pipe Height: **8.4** (in.) Rod and Bar (Angled)
Pipe Material: **Clay** ☐ Pipe Lined
Invert Depth: **8.00** (ft.) Flow Characteristics: **Fast**
Deposits: ☒ None ☐ Mud ☐ Sludge ☐ **Debris** ☐ Grease
Silt Depth: (in.) Deposits Extent:
Infiltration: **None** Pipe Seal Cond: **Sound**

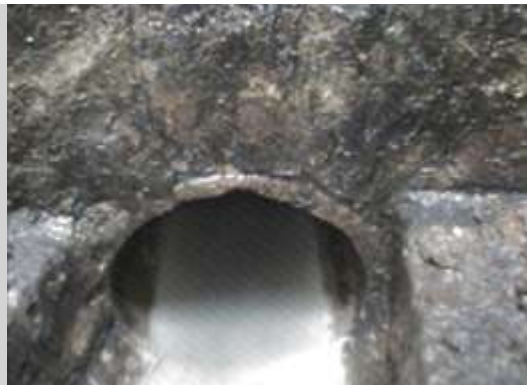
3 O'Clock Inflow

8 in. Circular Gravity Sewer
Pipe In @ 3 O'Clock

Pipe Height: **7.2** (in.) Rod and Bar (Angled)
Pipe Material: **Clay** ☐ Pipe Lined
Invert Depth: **8.10** (ft.) Flow Characteristics: **Fast**
Deposits: ☒ None ☐ Mud ☐ Sludge ☐ **Debris** ☐ Grease
Silt Depth: (in.) Deposits Extent:
Infiltration: **None** Pipe Seal Cond: **Cracked**

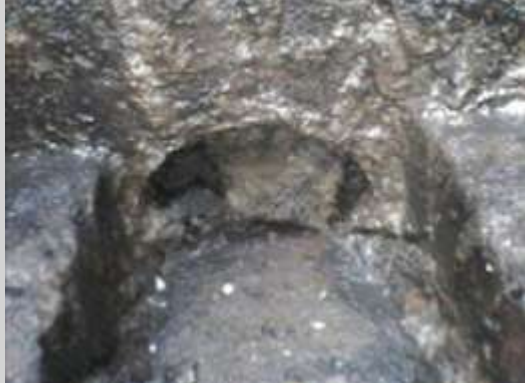
6 O'Clock Inflow

Comments **Unable to accurately measure influent pipe @ 6 O'clock**

8 in. Circular Service Sewer
Pipe In @ 6 O'Clock

Deposits: ☐ None ☐ Mud ☐ Sludge ☒ **Debris** ☐ Grease

Silt Depth: **4** (in.) Deposits Extent: **Heavy**
